PRECISE ALIGNMENT APPLICATION WITH BELZONA 7111 IN COAL MINE

Colstrip, Montana, USA

May 2017

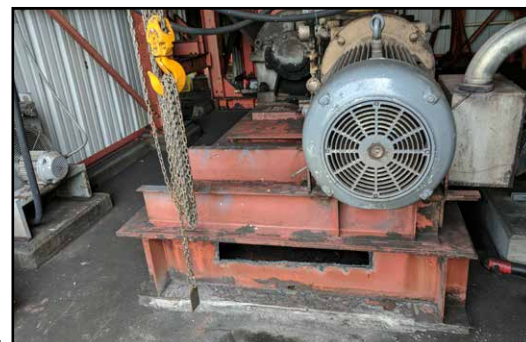
1. Old CST Drive
2. Anchored Bolts with Belzona 4151
3. Pouring Belzona 7111
4. Finalized Application
