PROTECTION OF NEW VERTICAL PUMP FOR POTABLE WATER SERVICE

Pump lining application to protect a new build vertical pump to supply potable water for a local water district in Texas, USA.

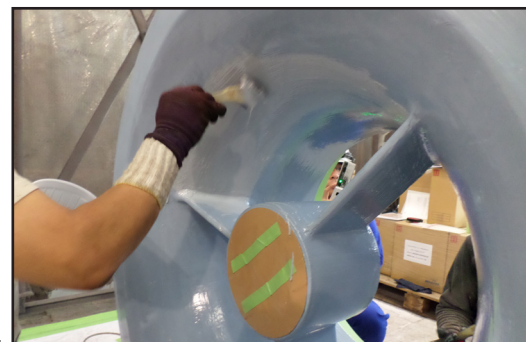
1. Application of 2nd coat on the Suction Bell
2. Spark testing the Suction Bell
3. Suction Bell completed
4. Discharge Bowl completed

Application was carried out in accordance with Belzona Know-How System Leaflet CEP-3, at the fabrication site of pump manufacturer in Japan. A suction bell and a discharge bowl were blasted and coated with NSF approved Belzona® 1341 internally. Blow holes found were filled with Belzona® 1111 to achieve smooth surfaces prior to the final coat of Belzona® 1341.
