## BELZONA KEEPS HISTORIC, 70-YEAR-OLD VESSEL STEAMING ON

Built in 1946, PS Waverley is one of the world's greatest historic ships and the last sea-going paddle steamer in the world. Listed among the National Historical Fleets records, the 70-year-old vessel still operates passenger excursions around the British coastline thanks to tireless maintenance efforts.

The famous vessel required maintenance to one of the steam cylinders on board. Belzona was chosen to rebuild pitting damage caused by the high temperature, steam conditions.

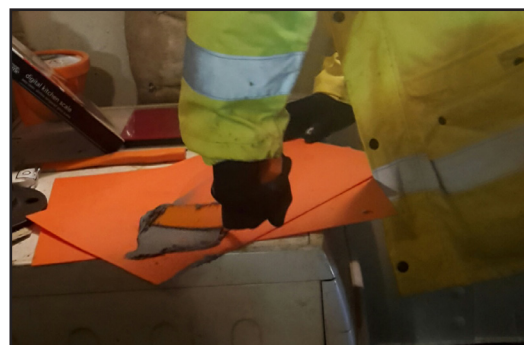
1. The PS Waverley is the last sea-going paddle steamer in the world.
2. Mixing of Belzona 1511 (Super HT-Metal).
3. The solvent-free material was ideally suited for the confined environment on board.
4. Application of the metal repair material to restore the pitted sections.

In order to combat the high temperature environment, Belzona 1511 (Super HT-Metal) was used to rebuild the pitted areas, able to be hand-applied and solvent-free. Once cured, the metal repair material was machined down to be flush with the surrounding areas. This application was completed using a modified version of ENC-4 system leaflet.
