BELZONA 5811 FOR NEUTRALIZATION BASINS AT A COAL FIRED POWER PLANT

Four concrete neutralization basins. The chemical neutralization of the water that goes back into the river from this coal fired power plant takes place in four concrete neutralization basins. The concrete must be protected from the chemicals.

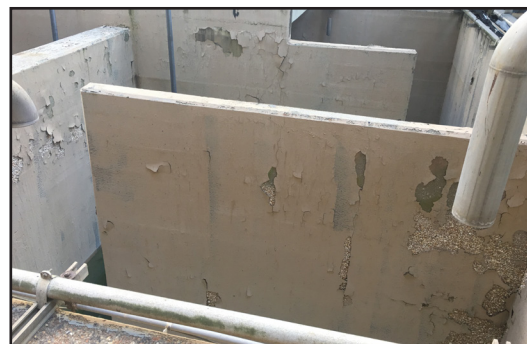
The chemical neutralization of the water that goes back into the river from this coal fired power plant takes place in four concrete neutralization basins. These basins had been coated with Belzona 4111 and over-coated with two coats of Belzona 5811 about 25 years ago. Gradually over the years the chemical attack had eroded some of the product. There was peeling of the walls and some places were down into the concrete substrate.

1. Neutralization basins after 25 years of the Belzona System.
2. The condition after pressure washing and brush blasting to remove all loose materials. Most of the substrate was in a good condition at that point.
3. Application of Belzona 4111, building up in layers to repair the holes in the concrete.
4. First coat of Belzona 5811.
