LANDING CRAFT WATER JET NOZZLES PROTECTED BY BELZONA

Stainless Steel water jet nozzles on a naval landing craft in dry dock.

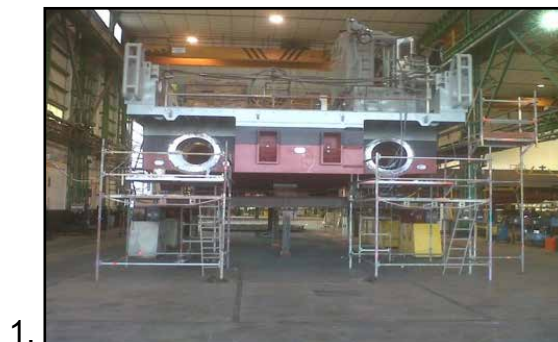
1. View of the vessel hull
2. Surface prepared, and Belzona 1321 applied
3. Belzona 1812 applied
4. Completed Application
