BELZONA COATS YACHT'S WATER JET SYSTEM

Coating of the water jet propulsion system of a newly constructed yacht.

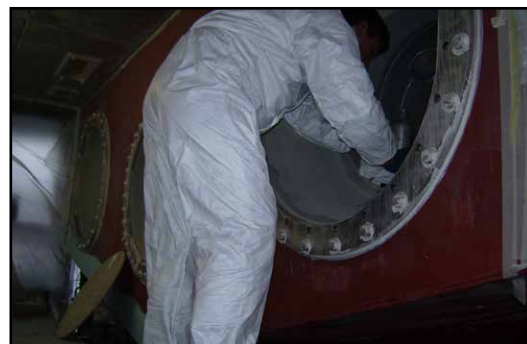
1. Water jets during the cleaning phase
2. View after the first coat of Belzona 1341
3. View after the second coat of Belzona 1341
4. Finished application

Application was carried out in accordance with Belzona Know-How system leaflet SOS-02. The substrate was blasted to SA 2.5 cleanliness and cleaned with acetone. 2 coats of Belzona 1341 were then hand applied to coat the system.
