## BELZONA INJECTION ON ARF LAY DOWN DECK FOR FPSO

FPSO's ARF laydown deck 24 m<sup>2</sup> was suffering from severe corrosion causing through wall defects in the 13 mm thick steel.

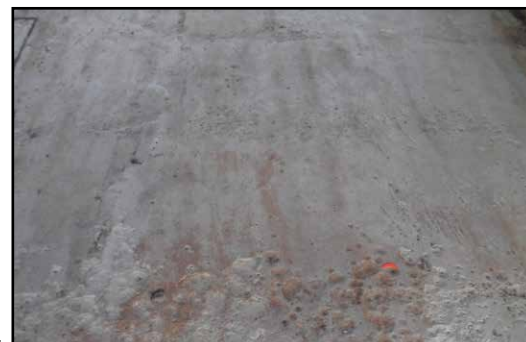
1. View of deck before grit blasting
2. Damage of deck
3. Alignment and injection
4. Completed job

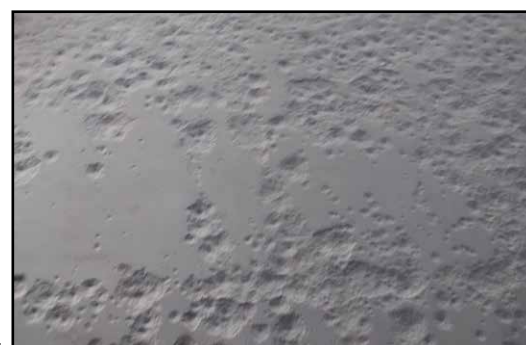
2.

The laydown deck allows the movement and storage of container deliveries, the deck was fitted with wooden batons to protect the deck from impact. The wood can withhold moisture and the deck's substrate is always around 30°C as the FPSO's generator operates directly below. This has caused accelerated corrosion through the 13mm steel.
