HIGH TEMPERATURE ABRASION PROTECTION WITH BELZONA

Newly installed pipeline on the digestive system of an Aluminium production facility required abrasion protection at elevated temperatures.

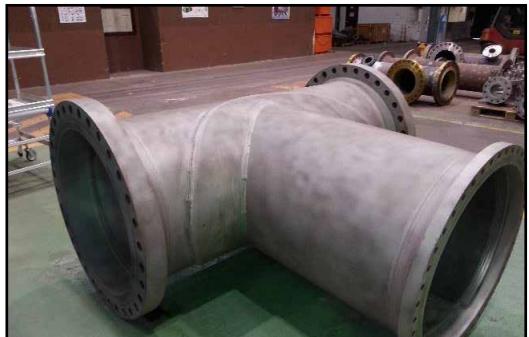
1. The newly fabricated pipe section
2. Internal surface prepared
3. Belzona 1511 and Belzona 9811 tiles applied
4. Belzona 1813 applied and Belzona 1391T top coat
