## DOUBLER PLATES BONDED WITH BELZONA TO FORECASTLE DECK

North Sea, UK

November 2008

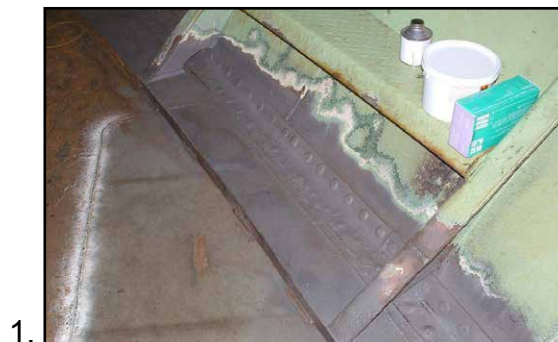
The vessel which was built in 1962 has a thick wooden decking covering the majority of the area with a 12" section of the deck plating exposed to act as a gutter way for directing sea water that comes onto the deck towards mid ships and scuppers.

The width of exposed deck plating has had thickness measurements carried out throughout its life and has shown signs of thinning. They needed to replace the lost metal and reintroduce the corrosion allowance, as the guttering is classed as part of the green deck (structural integrity of the deck), welding would require the area to be heat treated post welding to relieve any stress created by the welding.

1. View of Forecastle "Gutterway"
2. Application of Belzona 1151
3. Plate bonded to the deck
4. Completed application
