BELZONA PROTECTS OPERATORS IN A SUGAR REFINERY USING BELZONA 5871

L'Aube region of France

September 2020

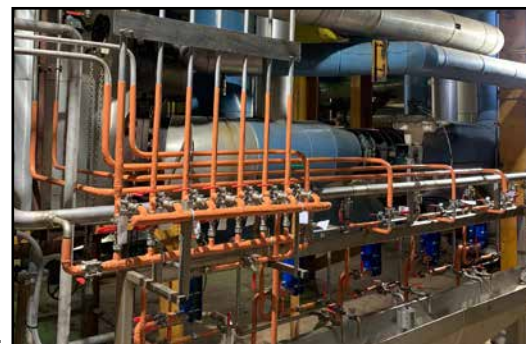
1. Belzona 5871 Final System Backside near Walkway
2. Belzona 5871 Final System Backside near Walkway (Close-Up)
3. Belzona 5871 Final System Purge Valve Access

The application was done in accordance with a modified version of Belzona's VPF System Leaflets. Belzona 5871 was manually applied using a brush no larger than 20mm wide, with the bristles cut down to 25mm. The product was applied to achieve a thickness of 6mm.
