BELZONA PROTECTS NEW-BUILD SEPARATOR FOR NATURAL GAS PLANT

Four new-build natural gas separators(Size: DN4000 X 30000(T/T)); Operating pressure: 1.1Mpa; Operating temperature: 100 °C; Media: Acidic natural gas.

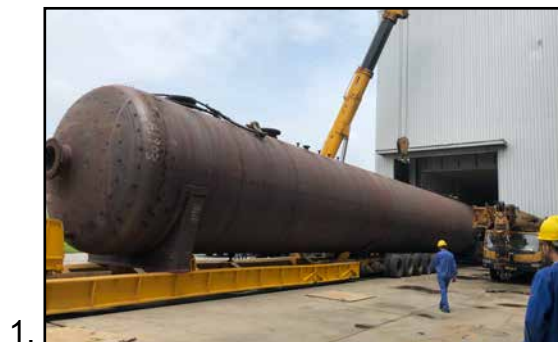
1. Exterior of the separator
2. Pre-coating Belzona 1391T
3. Spray applying Belzona 1391S
4. Application complete
