## BELZONA PROTECTS NEW-BUILD SEPARATOR

Six new-build natural gas separators(Size:DN4000 X 30000(T/T)); Operating pressure: 1.1Mpa; Operating temperature: 80 °C; Media: Acidic natural gas.

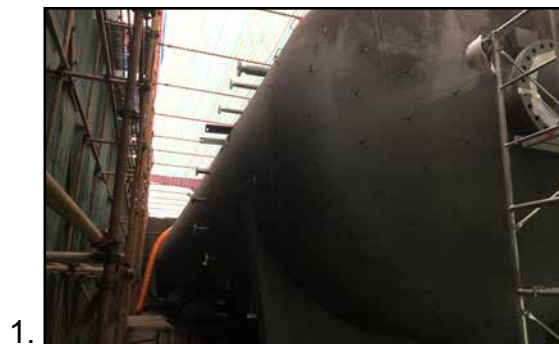
1. Exterior of the separator
2. Pre-coating Belzona 1391T
3. Spray applying Belzona 5892
4. Application complete
