## BELZONA COLD BONDING SYSTEM FOR WATER SPRINKLER TANK

**CUSTOMER**  
Indonesia

**APPLICATION DATE**  
2018

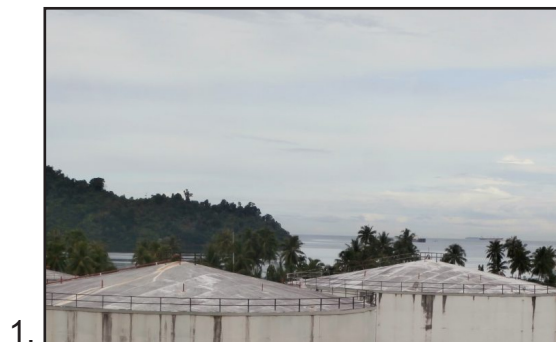
- PICTURES**
1. Crude Oil Storage Tanks
  2. Surface preparation by Grinding
  3. Bonded Bracket
  4. Completed Application
