LED LIGHT FIXTURE BONDING WITH BELZONA ONTO A HOSPITAL ROOF

CUSTOMER
Houston

APPLICATION DATE
2020-2021

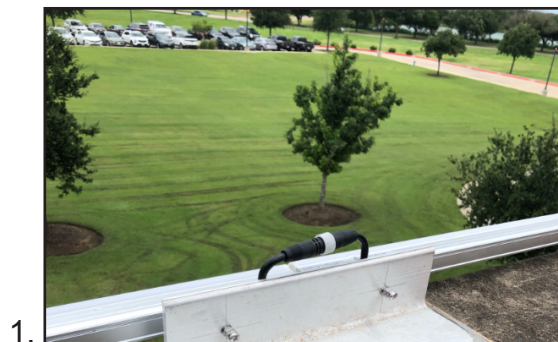
1. Close up of concrete bonding location
2. Overall Picture
3. Application onto metal coping.
4. View of fixture system

Aluminum angle brackets were to be bonded to the substrate in order to bolt on LED fixtures. The bottom of the brackets together with the substrate were prepared with a grinder to create a rough and clean profile. Belzona 4911 primer was used in all concrete locations. Belzona 1161 was applied to both the bracket bottom and substrate at about 1/16, 1/8 inch thick. The bracket was then firmly pressed down to the substrate and exuded material was used to chamfer around the edges. Once in place, holes were drilled into the brackets and the LED fixtures were installed.
