## BELZONA FLEXIBLE MEMBRANE PROTECTS CONCRETE TOWER FOUNDATION

Application of Belzona 3111 membrane to prevent water ingress via foundation cracks.

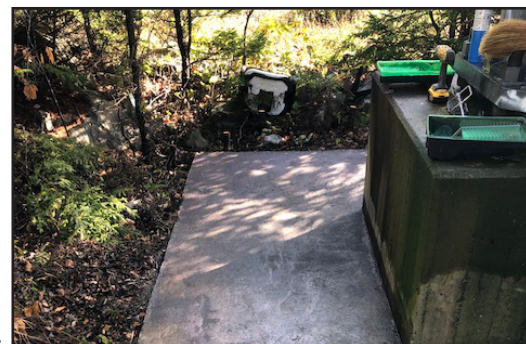
1. Cleaned foundation.
2. Foundation conditioned with Belzona 3911.
3. Finished Belzona 3111 application.
4. Membrane in good shape one year following application.

The coating application followed Belzona procedure WPA-1 for protecting and weatherproofing external surfaces. The foundation was first cleaned to remove all dirt and debris then conditioned with Belzona 3911. Once the Belzona 3911 dried, the Belzona 9311 reinforcement sheet was incorporated into the first coat of Belzona 3111. Once the first coat was adequately dry, the second coat of Belzona 3111 was applied.

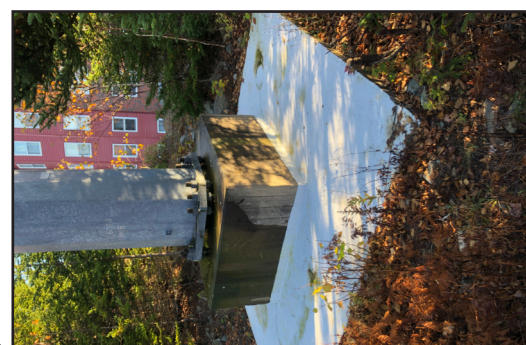
4.

Epoxy coatings have not performed well with the utility for the purpose of preventing water from getting into foundation cracks. The Belzona 3111 membrane was used as a trial for the benefit that the membrane will keep water out, and is flexible which means no cracking like an epoxy coating. The second coat of Belzona 3111 membrane was applied several hours before a Fall rain storm. The Belzona 3111 Membrane was unaffected by the rain, and continued to cure once the weather dried up. One year after the application and the membrane is still in good shape with water ponding on the top.
