ROLLER DOOR ENTRANCE REPAIR USING BELZONA

Huthwaite, UK

Sep-20

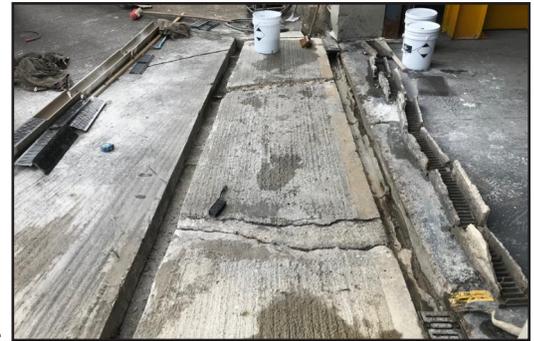
A concrete entrance had been compromised by years of wear from fork lift traffic running over a small concrete entrance pad which had suffered cyclic freeze/thaw in the winter, heavy rain and other erosive forces. The existing concrete had become compromised to a limit where it had become a safety hazard to run industrial traffic over the area

1. Prior to repairs
2. Finished application
3. Aco drains installed
4. Aco drains installed
