BELZONA® 4311 PROTECTS AGAINST SULFURIC ACID

Petrochemical Plant in Quebec, Canada

Vertical pump used for mixing a sulfuric acid solution

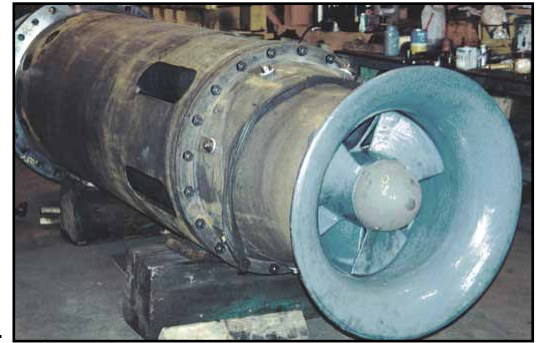
1. The acid pump
2. Inside view following surface preparation by grit blasting
3. The satisfied contractor admiring his work

Tremendous cost savings resulted due to the fact that the very expensive mixing pump has been preserved. At this facility, five identical acid pumps were treated with two coats of Belzona® 4311 (Magma CR1).
