## BELZONA SOLVES PROBLEM OF CORROSIVE ATTACK ON COPPER BAFFLES IN SUBMARINE

Copper baffle plates in submarine waste-water treatment system

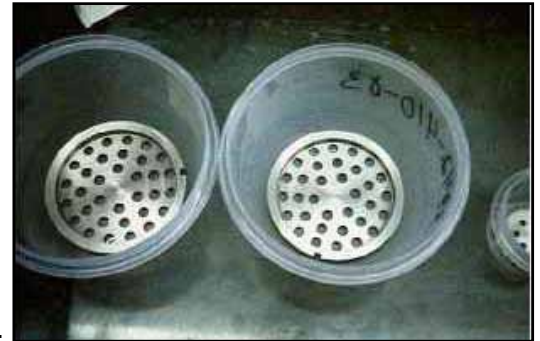
1. Prototypes to make mould
2. Belzona® 9411 applied to mould
3. Pouring Belzona® 1321
