BELZONA NON-STICK COATING FOR ICE CUBE IMPELLER

Chemical Plant in Argentina

Impeller of a system distributing special ice cubes throughout the plant

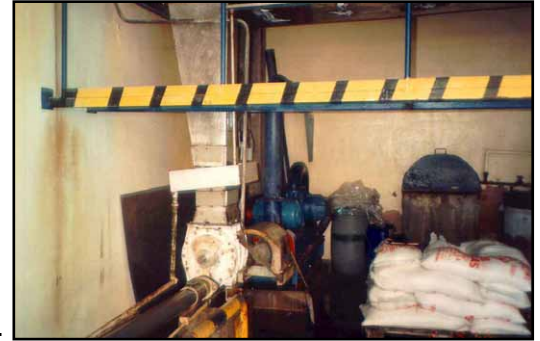
1. View of the ice distribution system
2. The impeller as seen through the inspection hatch, coated with Belzona® 1341
