BELZONA SAVES SCHOOL DISTRICT OVER \$10,000

School System - Florida U.S.A.

Insulated ductwork - HVAC

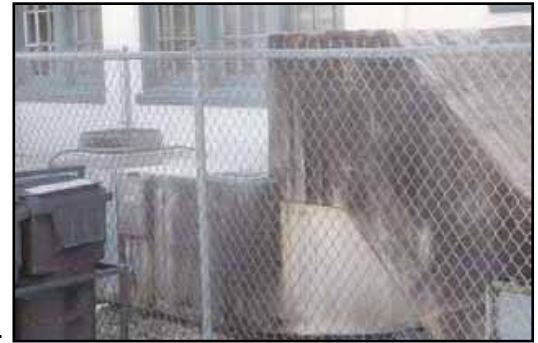
The insulated ductwork had a severe moisture problem. A product that would allow the moisture to dry as well as seal up the problem areas was needed.

1. The ductwork
2. Application in progress
3. The finished job
