BELZONA EXPANSION JOINT SYSTEM FOR BUSY BRIDGE

Florida Department of Transportation

Bridge spanning the Intracoastal Waterway - Broward County, Florida

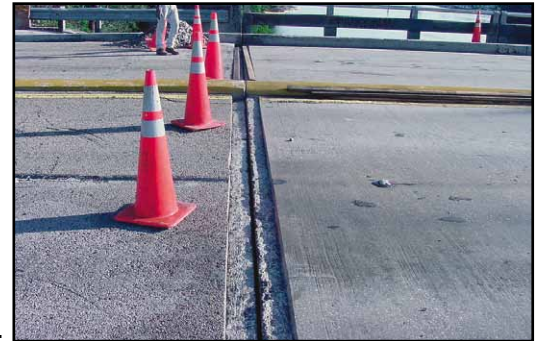
1. Joint prepared for nosing and seal
2. Completed Belzona system
3. Close look at seal
4. One year of service - without blemish
