## BELZONA PAVES THE WAY TO PARADISE

Florida Department of Transportation

Bridge, Florida Keys

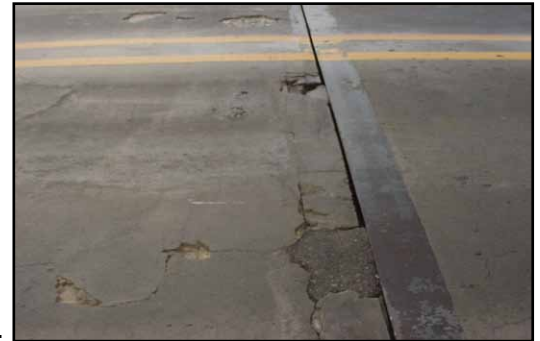
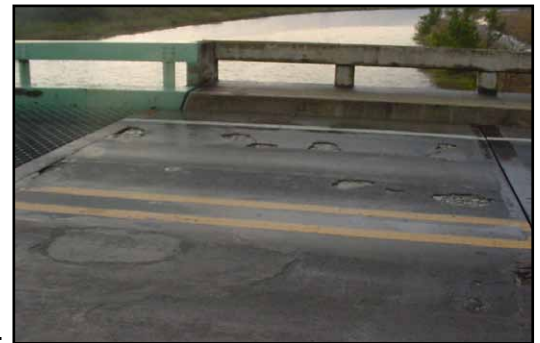
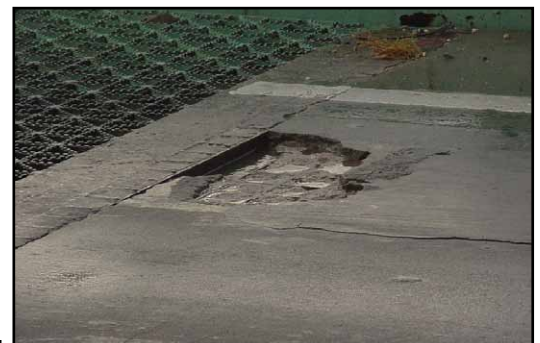
Bridge suffering from thermal cycling, heavy vehicular traffic and vibration, creating potholes and cracks.

1. & 2. & 3. Show various trouble spots
2. 4. Ready for traffic

Other conventional repair methods failed in very short time. Belzona® 4151 was mixed with pea gravel. This provided a base layer of material in the cracks and potholes. This was then overcoated with Belzona® 4111. The application took place overnight to minimize traffic interruptions.
