BELZONA PROTECTS CHEMICAL VESSELS FROM NEW

Chemical Plant in Italy

Vessel containing a mixture of Toluene, Benzene and other aromatic fluids in water at ambient temperature.

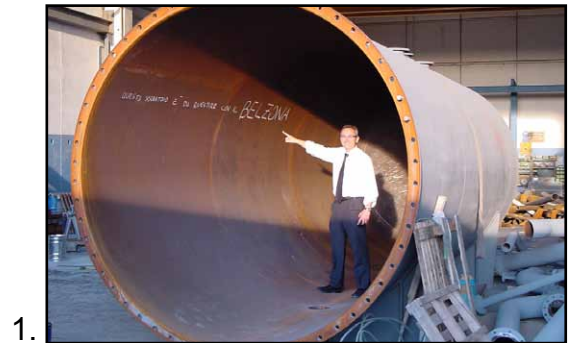
1. The vessel before preparation.
2. Belzona® 4311 being applied.
3. The completed application was like a work of art!
