## BELZONA ELASTOMERS USED FOR SWIMMING POOL EXPANSION JOINTS

Expansion joints in Olympic size swimming pool

Original expansion joint material was no longer effective

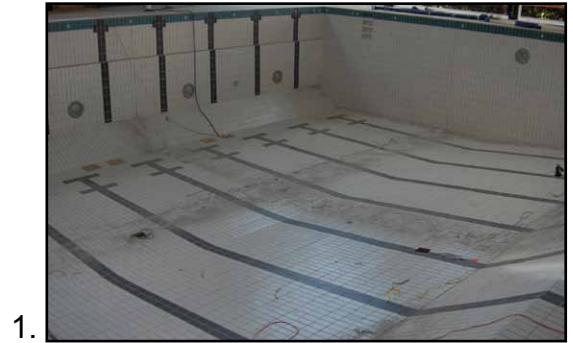
1. Preparation of expansion joints underway.
2. Grinding completed and masking of joints underway.
3. View of completed recreation section of the pool.
4. Close up view of completed joint.
