BELZONA PROTECTS LNG SPHERES

Chevron Pembroke

Pressurized LNG storage spheres.

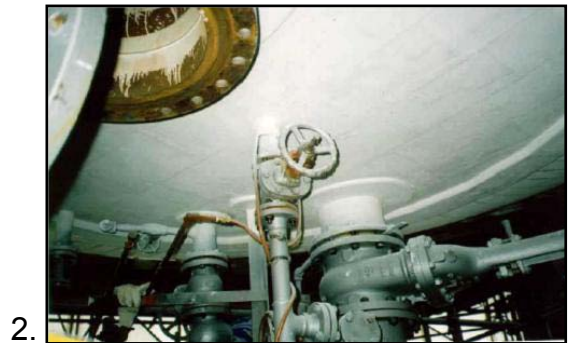
Water penetration through insulation causes severe Corrosion under Insulation.

1. Foam glass block insulation being fitted
2. View of unprotected (South) Polar region
3. The far right sphere was coated 11 years ago and is still good
4. Five spheres coated with Belzona® 3211 thus far

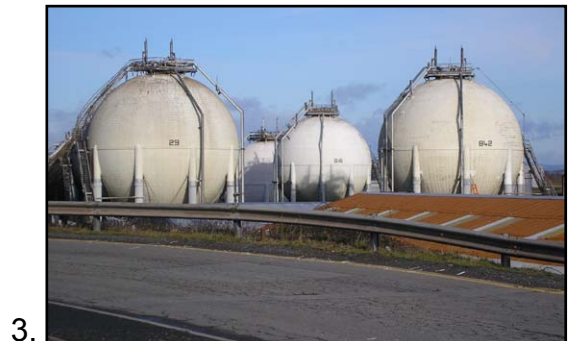
There have been several trials with alternative products, however, Belzona® 3211 is so far the preferred option. Main reason for this is the first sphere coated with the system has given 11 years service thus far, with no requirement for renewal. So far five spheres coated and further spheres planned to be coated in 2009.
