BELZONA PROTECTS PUMP FOUNDATIONS

Power Industry, Bulgaria

Dosing and mixing pumps in water treatment plant.

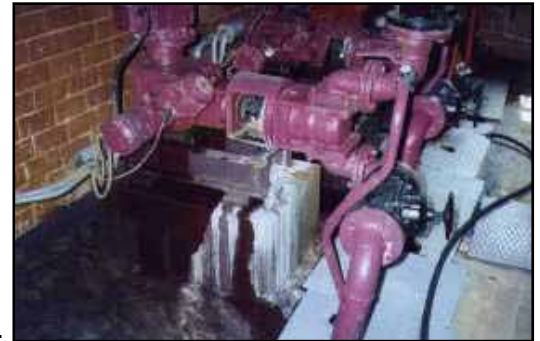
Leaks from the pumps destroy their unprotected concrete foundations.

1. Before coating applied
2. 1½ years after application

Belzona® 4311 provides complete protection from the chemicals used in the water treatment process. There is no damage after 1½ years service.
