## BELZONA IMPROVES CONVEYER EFFICIENCY

Automotive company, Slovakia

Elevated conveyer system

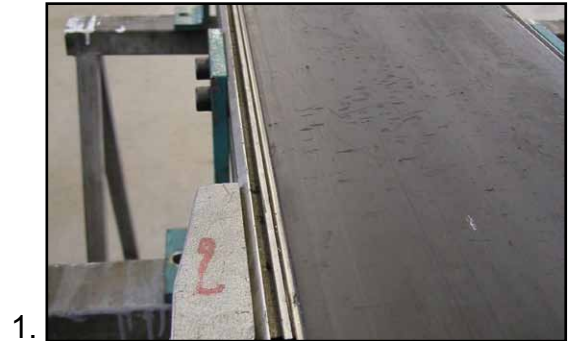
Products were sliding on the belt due to incline and smooth surface.

1. Slippery belt
2. Application of Belzona® 2211
3. Steel plates for moulding Elastomer to shape
4. Completed belt ready to work
