## BELZONA PROTECTS BUND

Chemical plant, Italy

Newly built chemical containment area

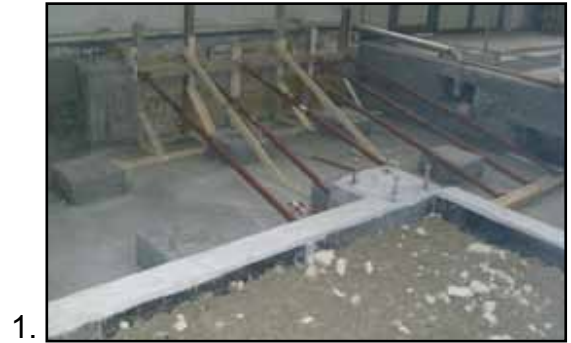
1. Construction of the chemical containment area
2. Application of Belzona® 4111
3. Application of Belzona® 4111 completed
4. Work completed with Belzona® 4181 and Belzona® 5811

Surfaces prepared by blasting. Two coats of Belzona® 5811 on internal walls, application of Belzona® 4111 on concrete base and finally Belzona® 4181 on areas in danger of accidental spillage. Work carried out in accordance with Belzona Know-How System Leaflets TCC-15
