BELZONA BONDS BUSHES INTO TETHER BLOCK

Oil & Gas Service Company, UK

Requirement to secure Bushes into the Tether Block for a 5 megawatts power generation buoy to be located in the North Sea

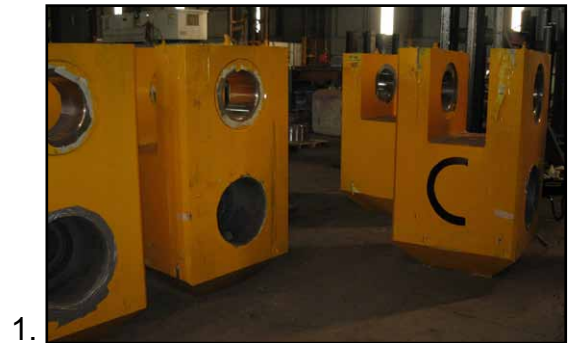
1. Tether Blocks
2. Bush
3. Dry fit of Bush
4. Completed job
