BELZONA PROVIDES SAFE PLATFORM FOR SLIPPERY WORK

Biodiesel Manufacturer, Memphis, Tennessee, USA

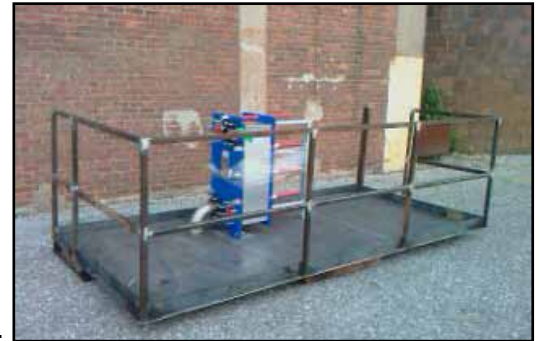
Workers would have to perform tasks that require them to have a safe walking surface so they would not fall. Biodiesel spills would create a slippery work surface on the carbon steel platform.

1. Platform prior to application
2. Platform after first coat of Belzona® 5811 with aggregate
3. Platform after project is completed
