## BELZONA PREPARES VERTICAL PUMP FOR ACID SERVICE

Refinery, Canada

Vertical pumps to handle sulfuric acid

Chemical attack inside volute and on the impeller.

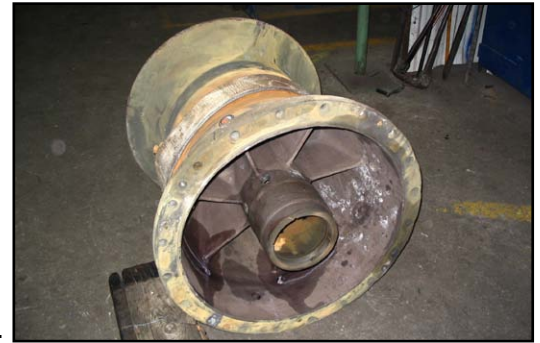
1. Original pump after 5 years
2. The volute after surface preparation
3. The volute after coating with Belzona® 4311
4. The impeller protected with Belzona® 4311
