BELZONA PROTECTS LOADING DOCK AND RIVER

Petrochemical Plant, South Louisiana U.S.A.

Loading dock for Sodium Hydroxide (caustic) on banks of the Mississippi.

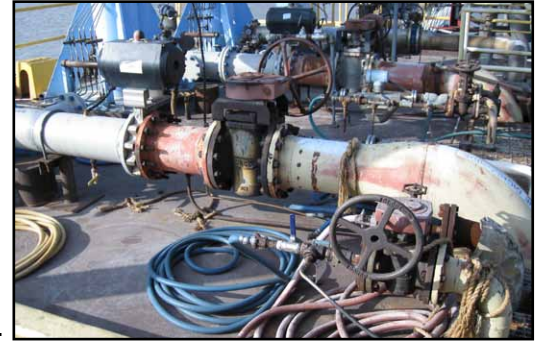
1. Overview of dock and river
2. Close-up of coating
3. Overview of containment area
4. Coating still resistant to standing caustic after 6 years service

The application was carried out in accordance with Belzona Know-How System Leaflets TCC-12, -7 and -15. Surface prepared by abrasive grit blast. The entire dock was overcoated with Belzona® 4311. Expansion joints and seams were sealed with Belzona® 2111.

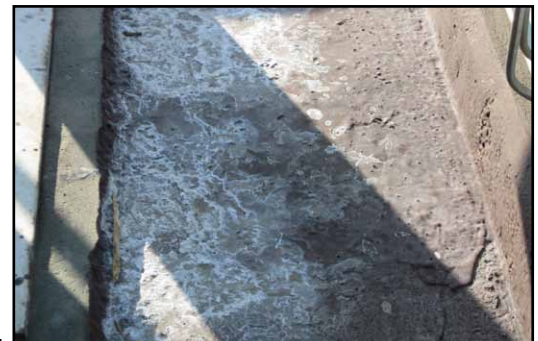
4.

The customer is responsible for containment subject to governmental regulation and potential heavy fine due to the close proximity of the dock to the river. Belzona was able to prevent contamination of the environment. Application has been in service for 6 years, and is in excellent shape today.
