BELZONA COATING FOR A CHEMICAL TANK

Tank F622 (diameter : 1,4mm, length : 3,5m)

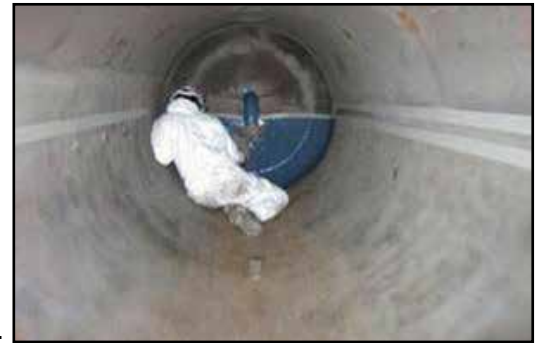
1. Tank after blasting,
2. Beginning of the application
3. On-going application of the coating Finished application

The application was done in accordance to Belzona system leaflet TCC-5. After degreasing and blasting the surface, Belzona 1391 was applied in a one coat system (600 to 750µm) on the bottom part of the tank.
