PROTECTION OF A CHEMICAL TANK AT VERY HIGH TEMPERATURE

Tank F110 (diameter : 3m, height : 3,1m)

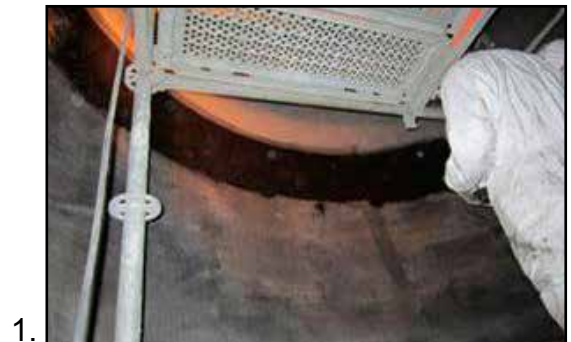
1. Blasted surface,
2. On-going application,
3. Finished application

Application was carried out in accordance to Belzona system leaflet TCC-5. After degreasing and blasting, Belzona 1591 was applied in a one-coat system (between 600 and 800µm).
