BELZONA RENEWS HOG ELBOW

British Columbia, CA

October 2014

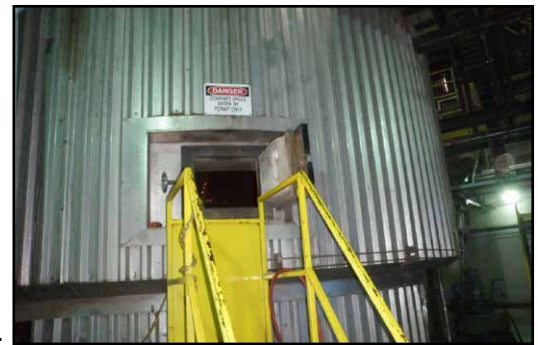
1. The burn chamber exterior and access door.
2. The interior of the elbow from above. The Belzona product from the original application 10 years ago is still visible.
3. Completed application.

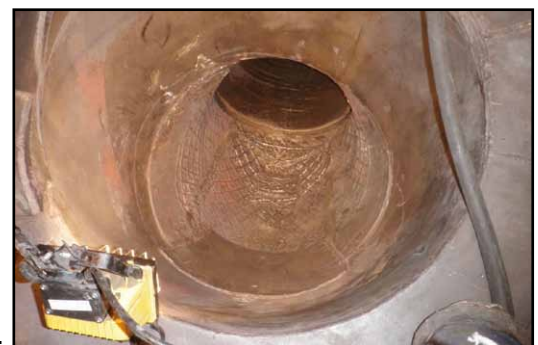
2.

The elbow wears where at one point it was criss-crossed with an AR weld. Unfortunately, the fuel feed would hang up on the AR weld pattern, causing the auger to work much harder.

The application was carried out in accordance with Belzona Know-How System Leaflet SHM-8. The surface was grit blasted; Belzona 1812 was applied by applicator and it was then overcoated with Belzona 1321 for smoothness.

This elbow is one of three originally surfaced in 2004 with Belzona 1812, which was found to not only protect the elbow, but significantly reduce auger torque as well. 10 years later this elbow needed a new coating and Belzona was asked to renew the application.
