BELZONA PROTECTS AGAINST HOT SULPHURIC ACID

Chemical Company, Warrington, UK

Tile and brick chemical containment bund.

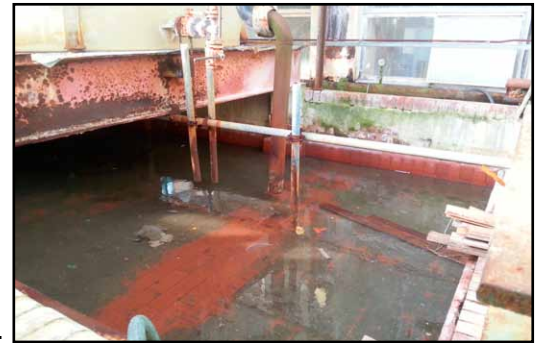
The tiles were on the base of the bund and a couple of inches up the walls. As the standing water levels were above the tiles, it was leaking through the bricks. The tank inside was storing 77% sulphuric acid at 70°C. It was therefore decided to coat the bund.

1. Damaged bund area
2. Damaged bund area
3. & 4. Completed application

The application was carried out in accordance with Belzona Know-How System Leaflet TCC-15. Belzona 4131 was used to create fillets at the horizontal and vertical junctions before Belzona 4341 was applied to protect the entire area.
