BELZONA ELASTOMERS SEAL SF₆ GAS LEAK

Electricity Substation, UK

October 2012

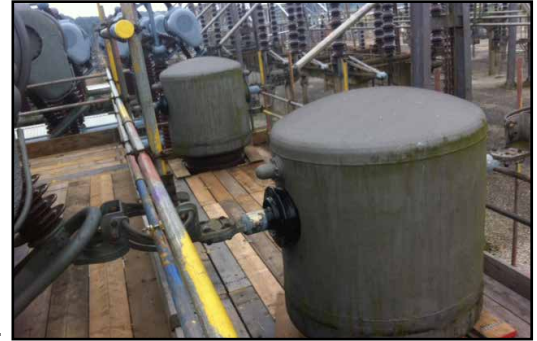
Six capacitor current transformers leaking SF₆ gas to Low Voltage side between bus bar and flange. The operating pressure was 45psi.

1. Visual view of equipment - horizontal bus bar
2. Substrate preparation completed
3. Conditioned and first Elastomer coat/joint sealing
4. Completed application with full encapsulation
