BELZONA PROTECTS NEWLY CONSTRUCTED BUND

Petrochemical plant, Canada

Newly constructed chemical retention bund

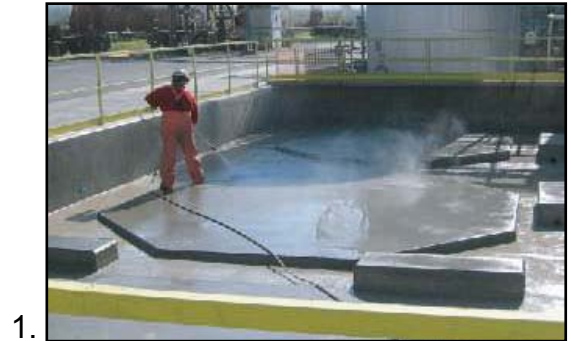
1. Surface preparation underway
2. Application of the Conditioner
3. Belzona® 4111 fillet applied to floor/wall joints
4. Application of Belzona® 5811. Note use of two colours to assist application

The application was carried out in accordance with Belzona Know-How System Leaflet TCC-15. Wall/floor interfaces were reinforced with a fillet of Belzona® 4111 before coating overall with Belzona® 5811.
