BELZONA WATERPROOFS NATURAL STONE FACADES

Private Building, Amman, Jordan

Natural Stone Facades

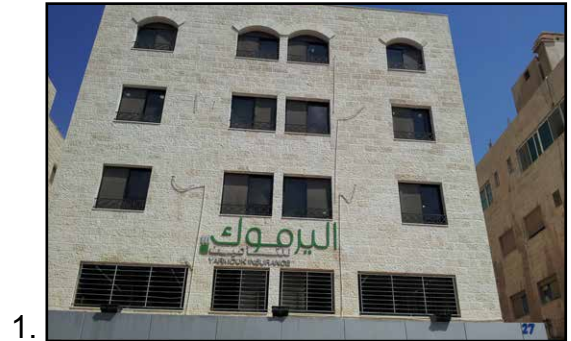
Water was penetrating the stones, creating damp areas on internal walls. The owner of the building needed to waterproof the structure and retain the natural appearance of the stones.

1. Front view of the building before application
2. Front view of the building after sand blasting
3. Applying Belzona® 5122 with spray unit
4. Front view of the building after finish of application
