## BELZONA PROTECTS 50,000 SQ.FT FLOOR AREAS OF A TECHNOLOGY CENTER & LABORATORY

Copper Mine, Arizona

Belzona floor coatings were specified to protect floor areas in a newly constructed Technology Center & Laboratory.

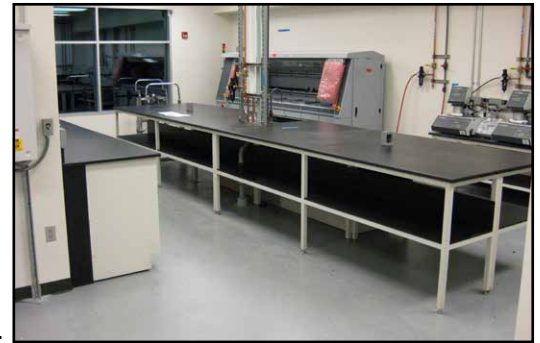
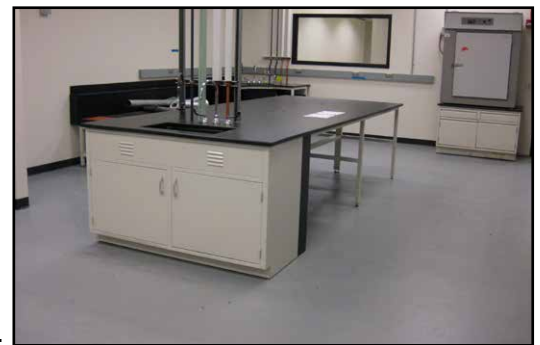
1. & 2. Laboratory floor areas protected with Belzona 4311
3. General floor areas protected with Belzona 5811
4. Laboratory floor areas protected with Belzona 4311

Application was carried out in accordance with Belzona Know-How System Leaflet FPA-3, following the 28 day curing process of the newly poured concrete. Belzona 5811 was applied to general floor areas and Belzona 4311 - to laboratory floors. The application of the coating systems was successfully completed using a combination of squeegee and paint rollers.
