BELZONA PROTECTS NEW PROCESS VESSELS FOR NATURAL GAS PURIFICATION PLANT

Major Oil and Gas Customer, China

Largest new-built Natural Gas project in China. It includes one plant with 12 million cubic metres capacity per day and another plant with 18 million cubic metres capacity per day.

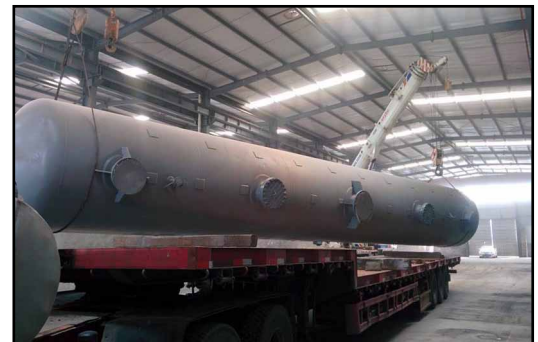
1. Overview of some vessels
2. Overview of interior of the vessels after blasting
3. Application completed and inspected
4. After 1 year in service, the re-inspection showed a "flawless" lining

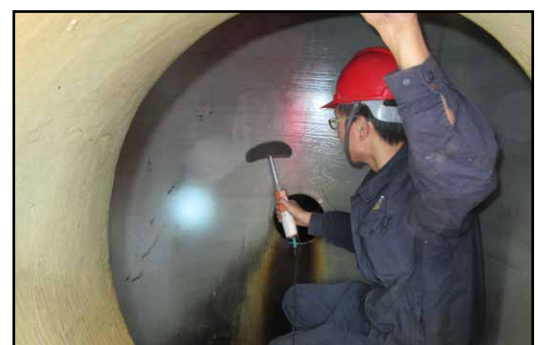
4.

The Belzona internal linings have been a cost effective solution, protecting the vessels from aggressive erosion and corrosion, while ensuring the plant operated safely. The application team was well trained by Belzona and strictly implemented the Belzona global application standard which enabled the application to be delivered to a high standard. After immersed in aggressive media such as acid solvent, sour gas and sediment for 1 year, when the vessels were inspected on-site, the internal lining showed no signs of deterioration.
