## BELZONA FLOOR COATING SYSTEM PROTECTS COMMERCIAL TRUCK LIFT ELEVATOR FLOOR

Toronto, Ontario, Canada

November 21, 2015

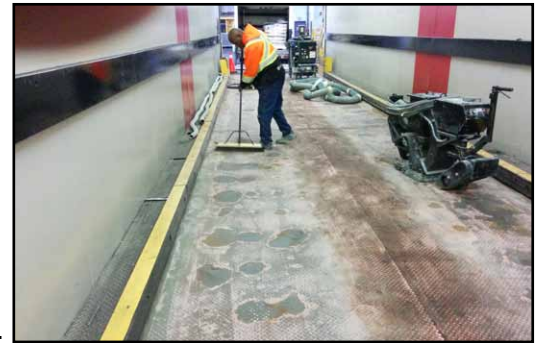
1. Truck elevator existing screed coating being removed and surface prepared
2. Damaged screed and corroded substrate
3. Belzona 9232 being broadcast into Belzona 5231
4. Completed application with Belzona 5233 top coat

Belzona 5231, 9232 and 5233 were all applied in accordance with the Belzona 5233 IFU and following the Belzona know-How system leaflet FPA-08 application of non-slip safety surfaces for floors. The substrate was abrasive blasted to the required standard, removing the failed screed material. The Belzona 5231 was applied by roller at a DFT of 10 mils (250 Microns), whilst wet Belzona 9232 was broadcast to rejection into the Belzona 5231. Once cured the excess Belzona 9232 was swept and vacuumed away and the top coat of Belzona 5233 applied by roller.

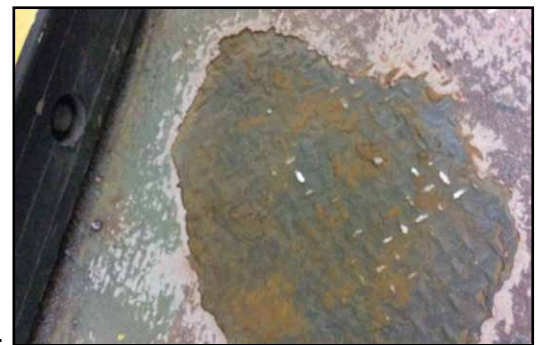
2.

Existing screed flooring covering a steel checker plate floor had failed due to a combination of corrosion, chemical attack (Road salt in winter), traffic load and movement. The failing screed had chipped off and was allowing the steel substrate to corrode. There were also concerns over cleanliness and slip & fall safety.
