UNDETECTABLE MOISTURE BARRIER FOR MUSEUM PROVIDED WITH BELZONA

Historic Museum, Teesside, UK

2010

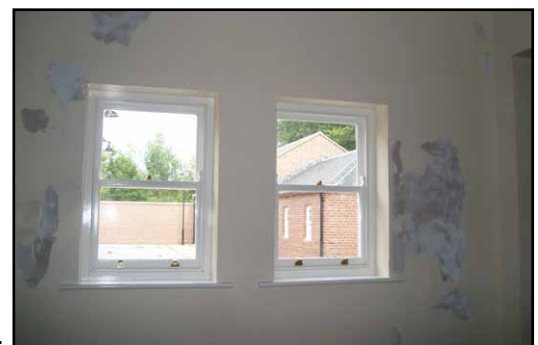
On the external walls of the East Lodge building, it was found that moisture ingress from driving rain quickly destroyed the newly refurbished rooms, wasting a large portion of the budget. A cost effective weather proofing solution that would not affect the appearance of the buildings was required.

1. Museum situated within Historic Estate
2. Damage to paint and plasterwork in classroom
3. Original application completed in 2010
4. East Lodge revisited in 2016

Belzona 5122 offers an invisible water repellent barrier that allows the surfaces to breathe and improves the thermal performance of saturated walls by up to 40%. Approximately 270 square meters of the external walls were quickly treated with a simple application that minimised disruption to the museum visitors. The surface was immediately weatherproof and undetectable to the naked eye. The client was delighted with the results and the refurbishment to the rooms within could resume without further risk. The protection of the building was reassessed 6 years later and found to still be working perfectly.
