BELZONA SUCCEEDS WHERE NOBLE METALS FAIL

Manufacturer, Varese, Italy

Ferrite wheel mixer

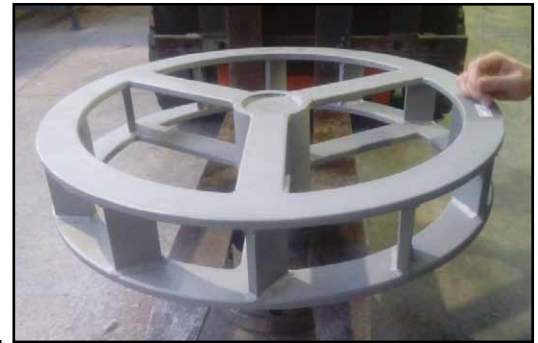
1. Carbon steel wheel after grit blasting
2. One of the templates used for the application
3. Application in progress
4. Completed application

The application was carried out in accordance with a modified version of Belzona Know-How System Leaflet SHM-13. Prefabricated custom made templates were used to carry out the application of Belzona 1811 at a thickness of approximately 10mm on all surfaces of the wheel. Belzona 4151 was then applied to provide a glossy finish.
