BELZONA GRIP SYSTEM OUTSTRIPS THE COMPETITION

Pharmaceutical Company, UK

Grip Coating for Ramps and Corridors.

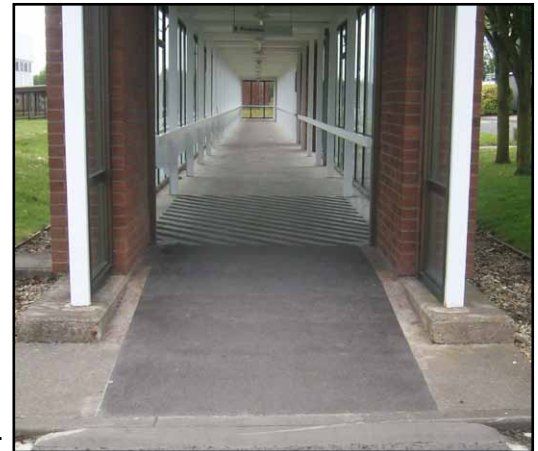
1. Original application revisited after 6 years
2. Typical condition of tapes after 3 months
3. Belzona application extended in 2011

Belzona 4411 is solvent free and applied in a single coat, making the application very fast and ideal for sensitive areas. There are also a choice of colours and aggregates that can even survive heavy vehicle traffic. In 2016 the original areas were revisited and Belzona system continued to offer superb performance after 11 years continuous service.

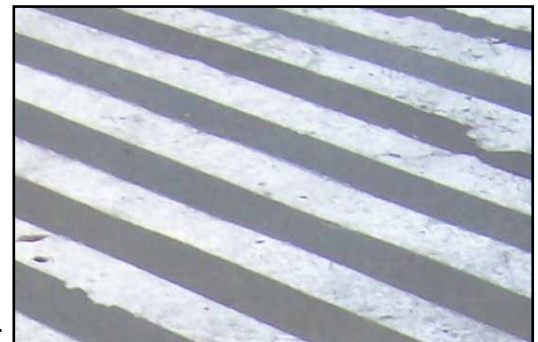
2.

In 2005 the client had used Belzona 4411 on a series of external ramps to avoid slip incidents. As they later found adjacent areas that were undercover were also hazardous, they applied slip resistant adhesive tapes from a leading manufacturer. Unfortunately, the tapes would repeatedly fail and the loss of adhesion at the edges meant that they became trip hazards. These tapes would have to be reapplied every 12-18 months which was costly and disruptive. In the same 6-year period the Belzona materials had suffered only very minor damage, and so the client decided to extend the original application onto the undercover areas.
