## BELZONA TANK BASE SEAL TAKES CARE OF THE DETAILS

Petrochemical Plant, UK

Carbon Steel Flare Stack

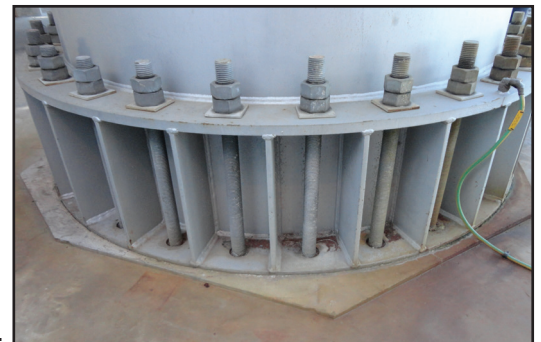
This hydrogen flare stack had recently been installed on site, but gaps around the "hold down bolts" had resulted in water ingress to the underside of the stack. Several solutions were considered, but with 28 bolts and fins to accommodate, the obvious choice was a Belzona Tank Base Seal solution.

1. Initial condition for Flare Stack
2. Close-up of hold down bolt gaps
3. Gaps filled and surfaces primed
4. Tank Base Seal completed in 2013
