BELZONA SOLUTION FOR TRICKY PIPE PENETRATION

Pipe penetration was allowing rain water to leak through the wall into workspaces at a local hospital.

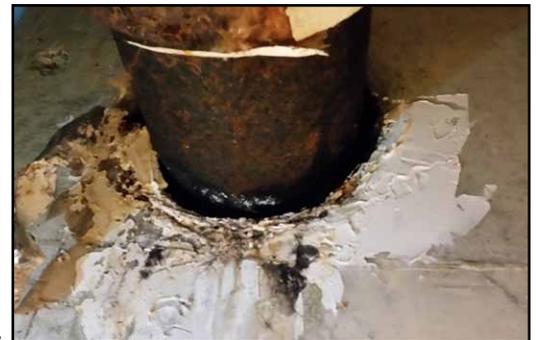
The pipe penetration is in a basement wall above the suspended ceiling. The exterior of the wall is under 10 feet of earth and concrete so the customer needed a way to solve the leak from the inside of the wall. They also needed a solution that would work with multiple substrates.

1. Leaking pipe penetration with remnants of previous repair attempts using caulk and plaster
2. Pipe and concrete cleaned and ready for conditioning
3. Conditioned area ready for application of Belzona 2211, a foam filler was used as a backer in the area between the wall and the pipe
4. Application complete with a flexible two layer 'boot' that is seamlessly adhered to the pipe and wall
