BELZONA BONDS BEARING PADS ON TIDAL TURBINE

Tidal energy developer, Inverness, Scotland

New design for a sub-sea turbine being produced.

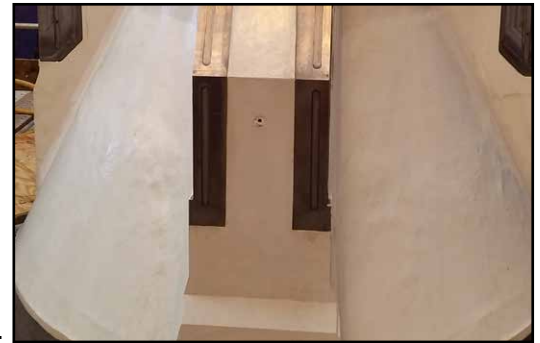
1. The stab prior to application of bearing pads
2. Wetting out the area
3. Application of Belzona 1321 on to bearing pads
4. Bearing pads bonded in place with bolt holes filled
