BELZONA 5122 CLADDING PROTECTS A BRICK AND MASONRY STRUCTURE AT A UNIVERSITY BASEBALL STADIUM

Brick and Masonry structure at a university baseball stadium. The structure hosts a press box and houses electronics that are important for the game broadcastings.

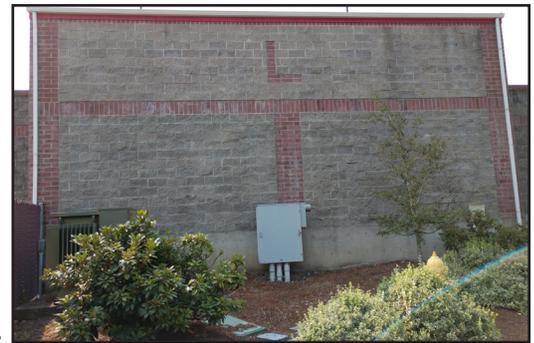
The structure needed to be protected from water ingress and water penetration, as the water penetrating inside was corroding metal components of these electronic systems, threatening their operation. The University had used Belzona 5122 on other buildings in the past and had confidence that Belzona could fix the problem while retaining the original aesthetics of the stadium.

1. The wall needing protection from water penetration
2. Corrosion had begun to degrade the internals and threatened damage to electronics
3. Application of Belzona 5122
4. Stadium protected and ready for the games
