## BELZONA SPIN SPRAY APPLIED PROTECTIVE COATING FOR SCRAPER TRAPS

Oil Field, Saudi Arabia

2017 - 2018

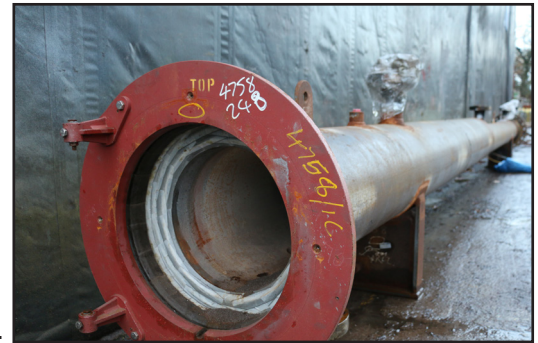
1. Scraper trap prior to application.
2. Calibration.
3. First coat applied.
4. Application complete.
